**PACFISH Buffer and
Temporary Road Monitoring and
Miscellaneous Timber Sale
Observations Report**

**Lochsa/Powell Districts
Nez Perce-Clearwater National Forests**

December, 2016

Prepared by Karen Smith, Central Zone Fisheries Biologist

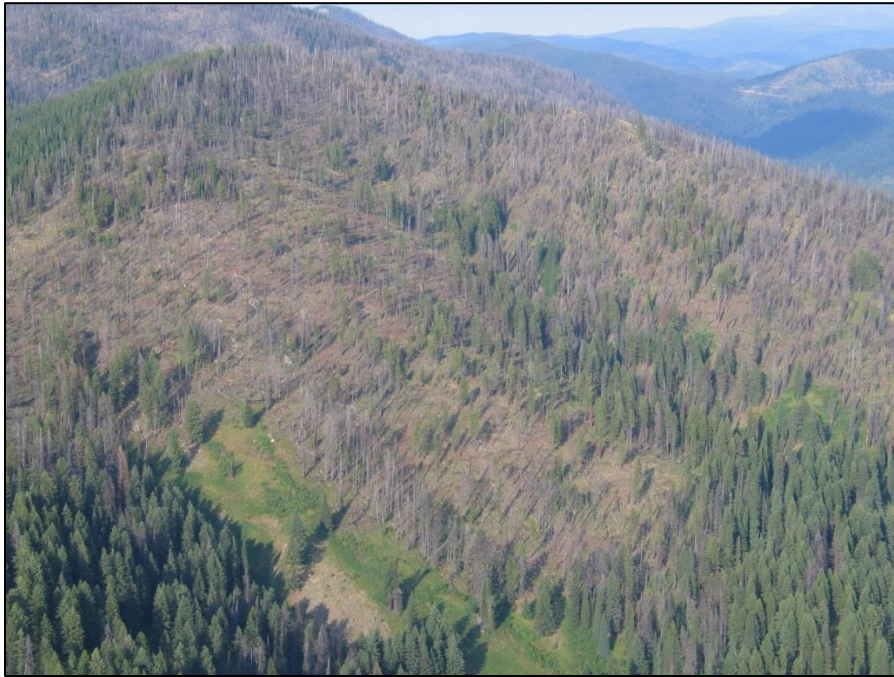
Photo 3. Unit 1 post-harvest.

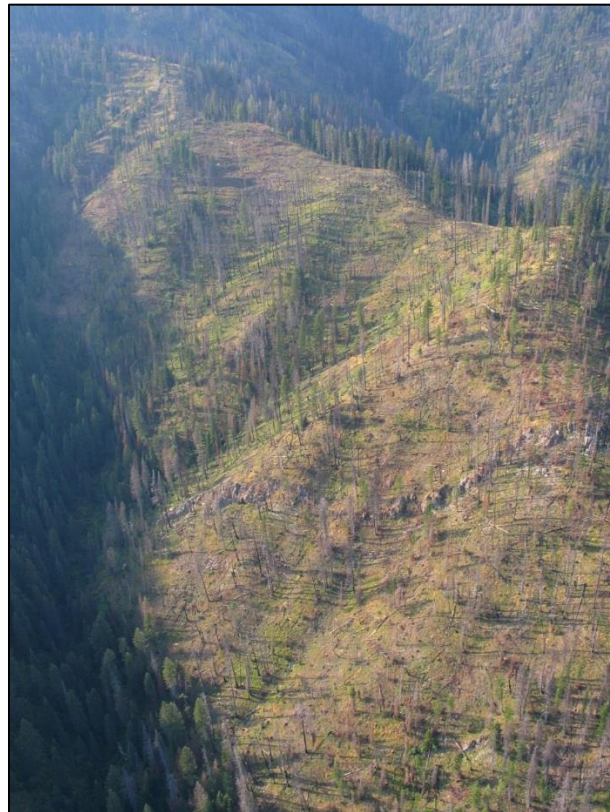
Photo 4. Unit 3 post-harvest

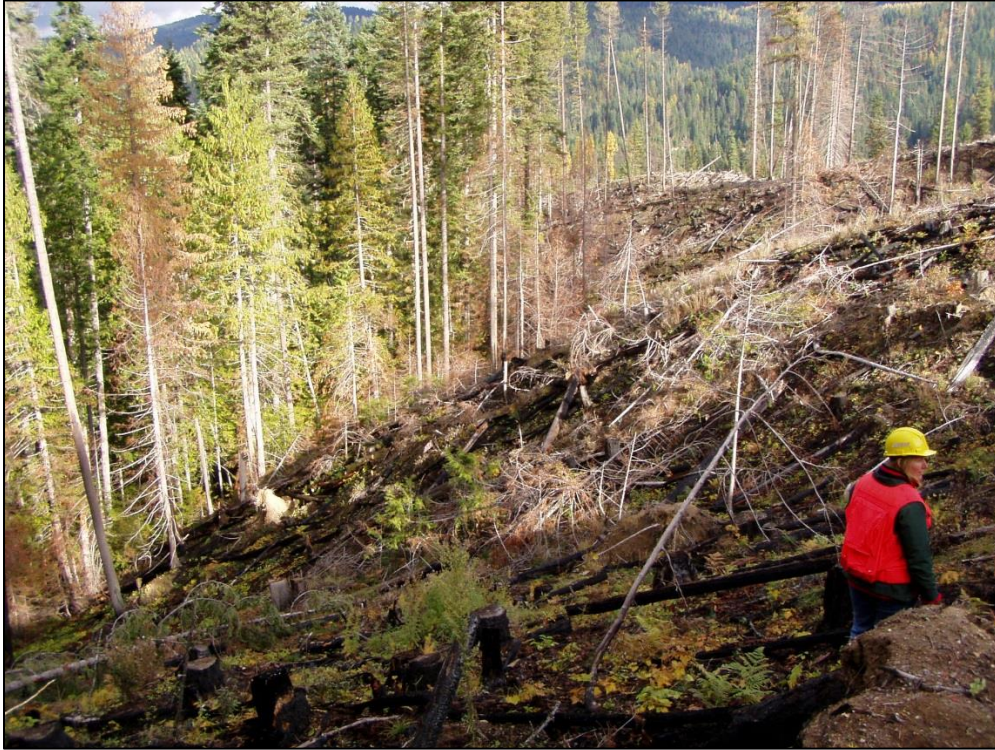
Photo 12. Buffer on downhill edge of Unit 6, 2006.

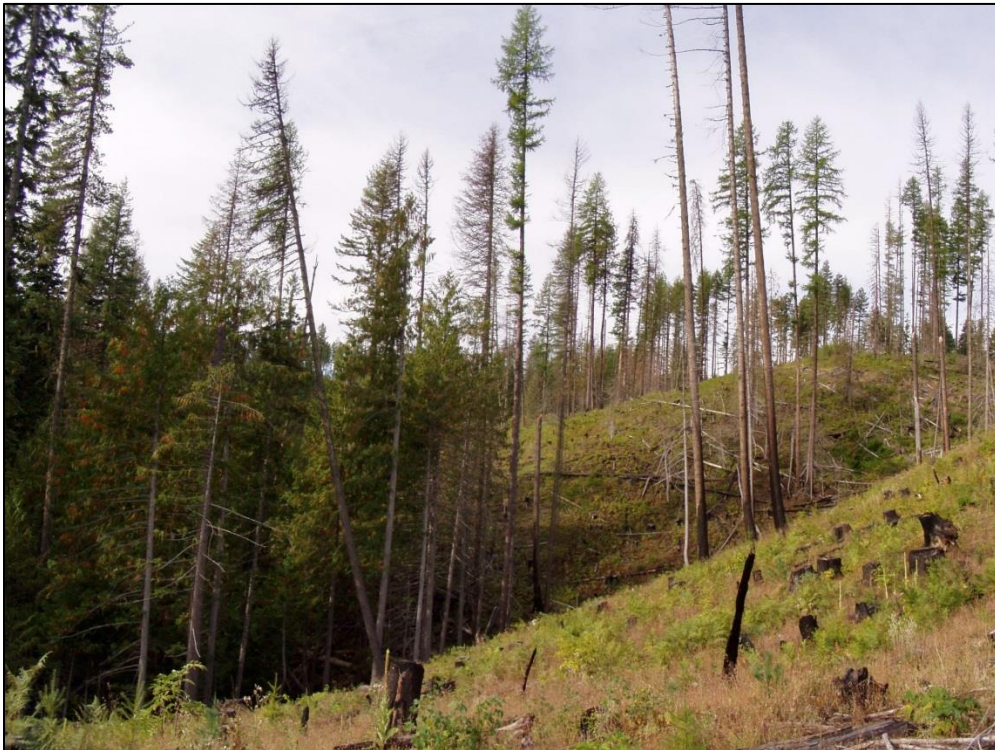
Photo 13. Unit 6 in 2008, two years after review.

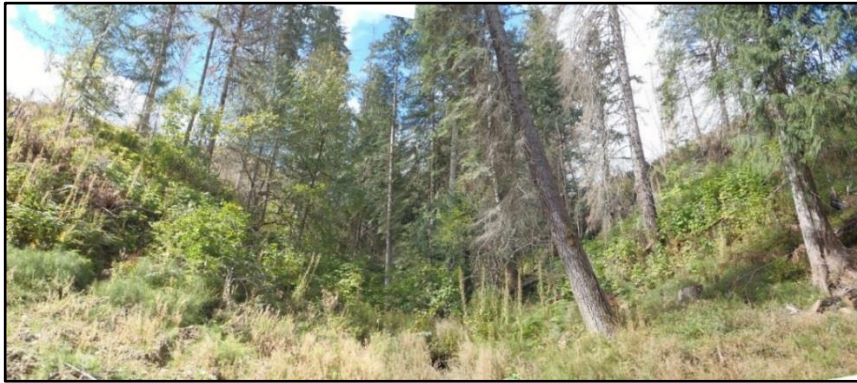
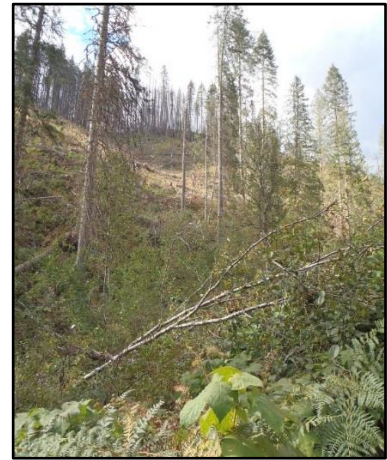
Photos 14 and 15. IDL buffer on Burnt Creek (left) and private lands on Elk City Creek (right).

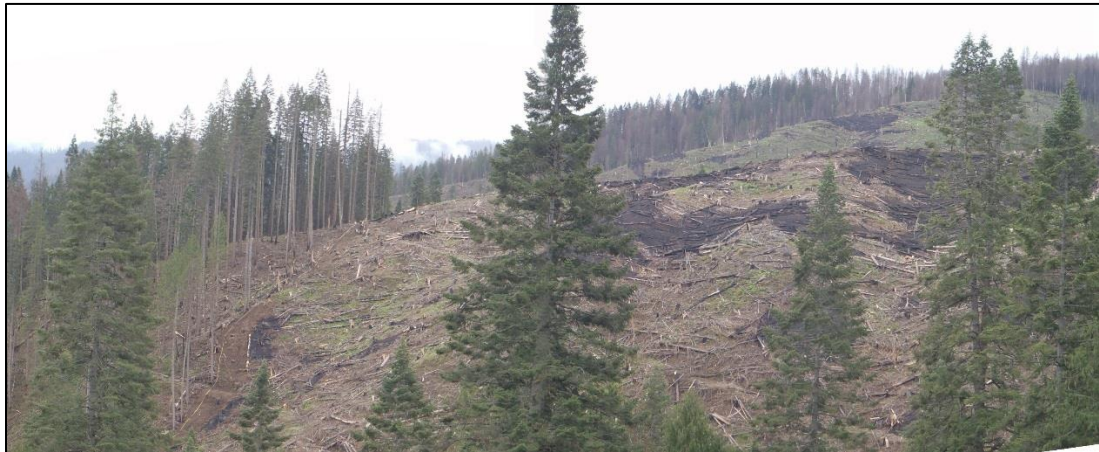
Photo 16. Abundant surface material after IDL harvest and burning, 2016

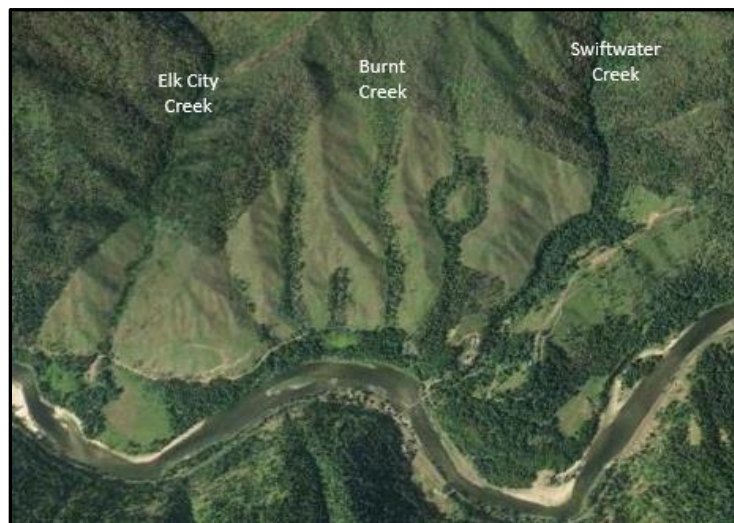
Photo 17. Google Earth view of streamside buffers on IDL and private lands.

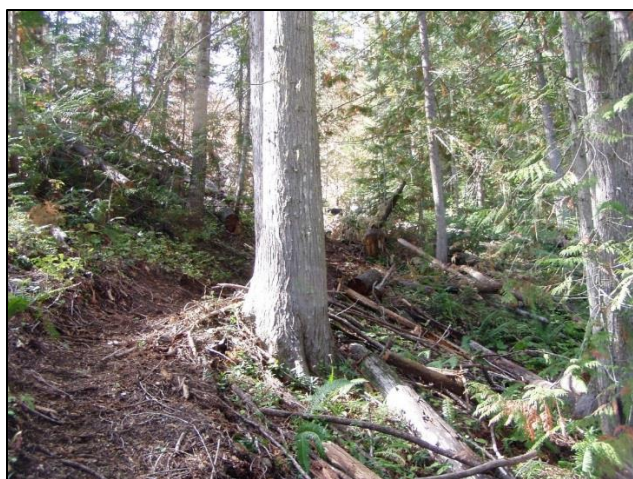
The RHCAs themselves are comprised of thick vegetation and downed woody material which act as a virtually impenetrable, filtering source for overland sediment flow (Photos 18 and 19). It is extremely unlikely that sediment would be delivered to streams through the RHCAs as a result. The results of this monitoring are consistent with local BMP monitoring on the Clearwater National Forest which has occurred since 1990. Between 1990 and 2008, the Forest had BMP implementation and effectiveness rates of 97% or greater (USDA, 2009). BMP audits on state and private forestry lands also had good results as well even though buffer widths were typically half or less the width of PACFISH RHCAs (Cristan et al 2014; Sugden et al 2012; Lakel 2010; Lee 2004).

Photo 18. RHCA interior (with fireline).

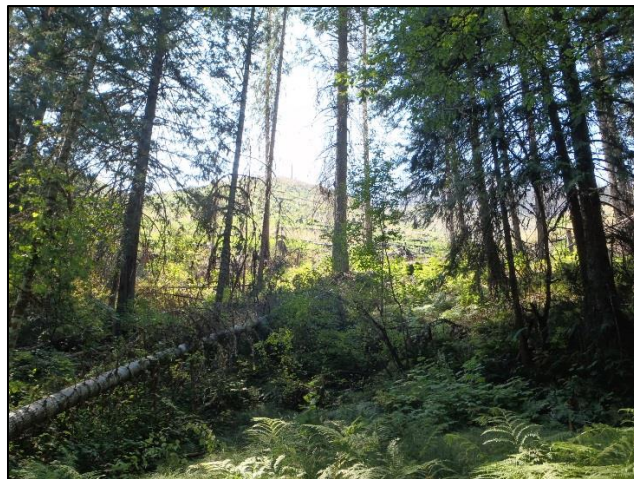
Photo 19. IDL buffer interior (Swiftwater Cr.).

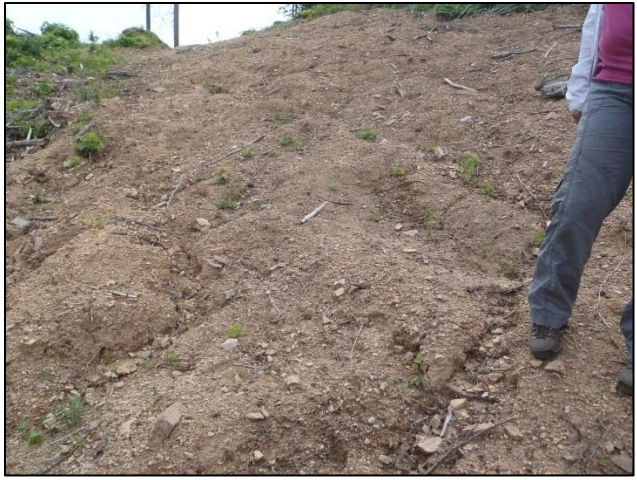
No erosion was observed on 12 of the 13 surveyed roads. Limited erosion was noted on one road (Yakus Unit 9, harvested in 2008) and none of the sediment was delivered to RHCAs or streams. The sediment was delivered into a roadside ditch where it was diverted through a cross drain culvert away from live water. The road was constructed on a side slope and was full recontoured; however, no woody material was placed on it as it was used as a fire break during broadcast burning activities. Rill erosion was noted on the road surface, some of which travelled down the slope and into the adjacent permanent road ditchline (Photos 20 and 21).

Photo 21. Erosion on temporary road.

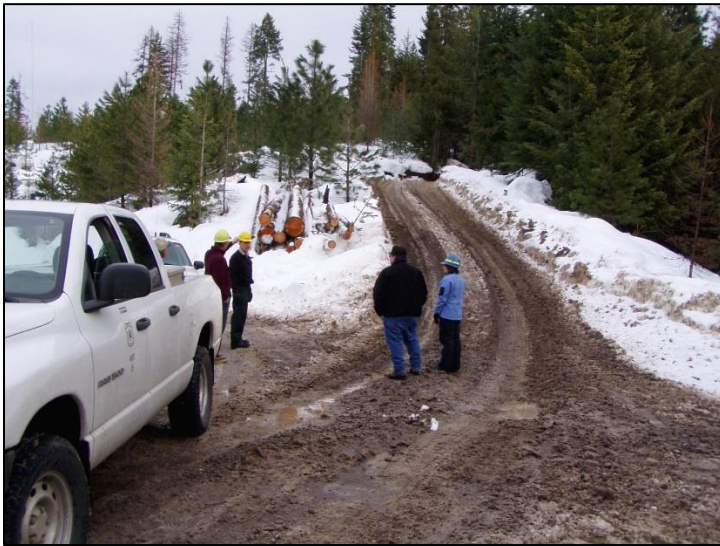
Photo 22. Temporary road in used, winter 2009 (White White Unit 32).

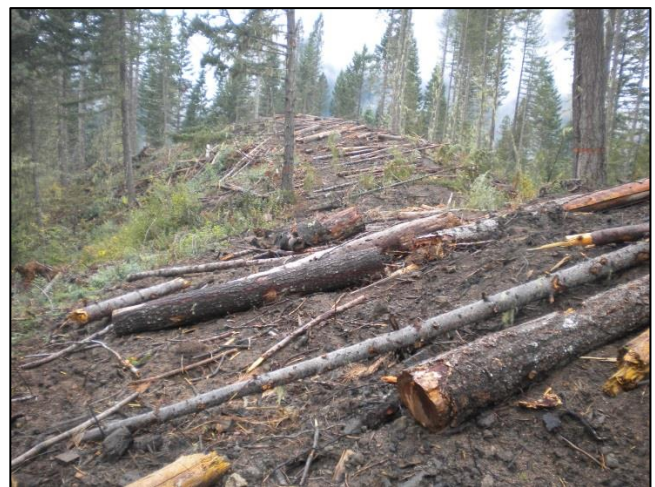
Photo 26. Saddle Camp temporary road, 2015.
